CASE STORY

General Electric 1.5 MW Wind Turbine (10007)

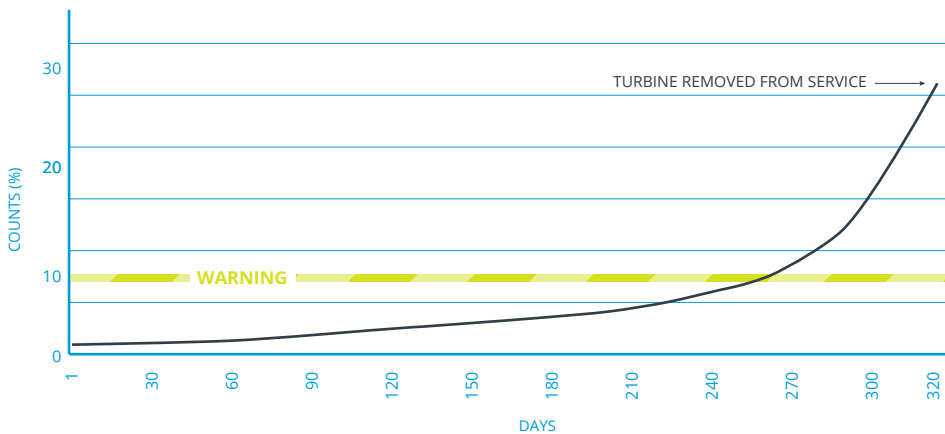
Time History of Events

Debris was detected at a moderate rate after installation of MetalSCAN, surpassing the warning limit (10% of the alarm limit) after 266 days. The rate of debris accumulation increased significantly after day 287, indicating more rapid progression of damage, triggering, and being confirmed by, a videoscope inspection. The wind turbine was shut down to prevent secondary damage, and the gearbox was subsequently removed for repair and replaced with a healthy unit.

TURBINE WAS RUNNING CONTINUOUSLY THROUGHOUT THIS PERIOD

ONLY LAST 320 DAYS SHOWN

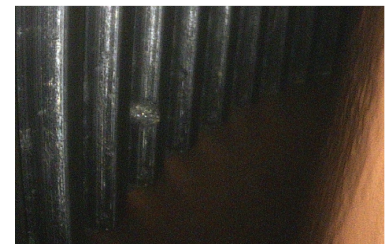
Wind turbine was operating for seven years without incident. MetalSCAN was installed as a diagnostic tool to measure degree of damage as a result of damage observed on a planetary stage gear teeth through videoscope inspection.

Damaged Ring Gear
