CASE STUDY

GE LM1600 – Power Turbine Bearing Failure

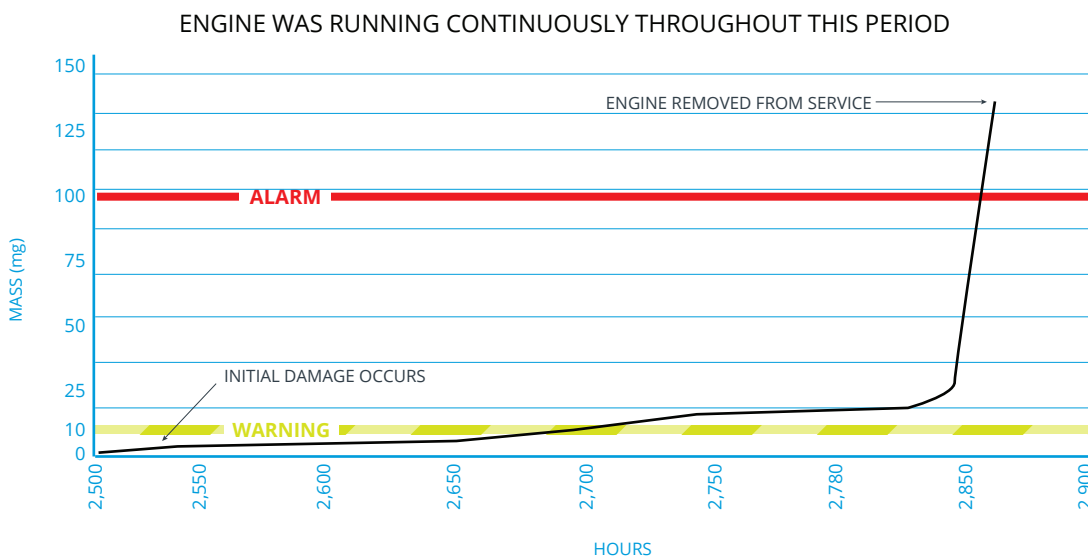
Time History of Events

Presence of particles first detected by MetalSCAN at 2,500 operating hours, followed by a sharp rise. A replacement power turbine was dispatched from the spares pool. A chip detector alarm was triggered at 2,550 hours. The turbine was shut down based on readings from MetalSCAN 75 operating hours after first detection and the power turbine was changed out. At shutdown, the total debris mass on #8 and #9 scavenge line was over the MetalSCAN alarm limit with no change in vibration or scavenge oil temperature. The MetalSCAN sensors monitoring the other bearings showed no rise of debris.

- ✓ Only last 14 days shown
- ✓ Four days of notice before shut down
- ✓ 170 hour planning period provided
- ✓ Damage located to power turbine
- ✓ Lease power turbine was brought to site before engine shut down
- ✓ Lost production limited to two days over low demand weekend period
- ✓ Secondary damage avoided
