CASE STUDY

GE LM2500 – AGB Failure

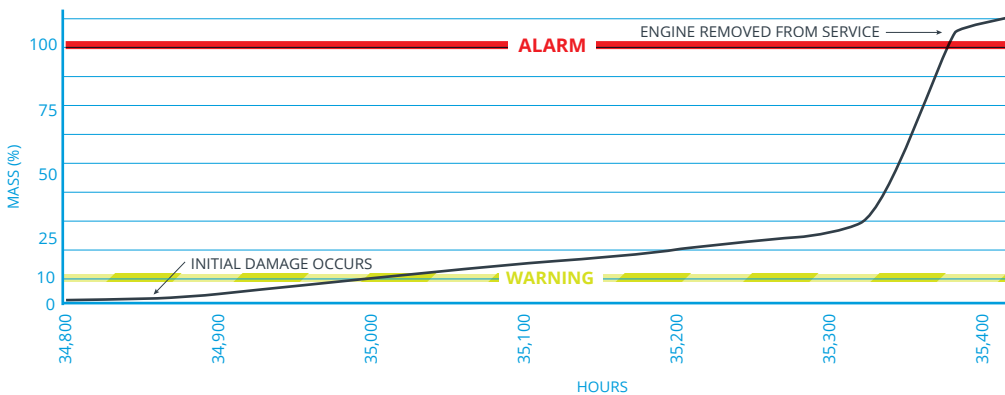
Time History of Events

The MetalSCAN warning limit was reached two weeks after the AGB sump debris counts began to rise. A slow progression of debris counts continued for two more weeks before the debris detection rate increased sharply, quickly reaching the alarm limit. The engine was stopped and the Depot replaced the AGB module in-situ for a brief outage before the engine was restarted. The Depot teardown revealed a starter shaft bearing failure. The AGB was easily repaired within two weeks and returned to the customer. There were no chip detector, temperature, or vibration abnormalities indicated.

ENGINE WAS RUNNING CONTINUOUSLY THROUGHOUT THIS PERIOD
