Background

Event Description

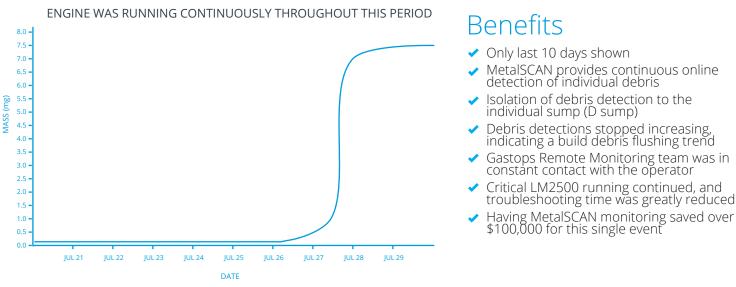
Time History of Events

The zero time overhaul engine was started on July 26th. After start-up, the D sump MetalSCAN sensor counted 38 particles with total mass of 7.5 milligrams. As the engine continued running, the counts remained well below under the D sump mass limits, and the count rate gradually began to reduce. By July 28th, the counting had reduced to the normal near zero level. The Gastops Remote Monitoring Team was in contact with the operator throughout the event reviewing the MetalSCAN data. Continued operation with close monitoring was advised to identify if this was a typical post-overhaul build debris flushing event. The reducing count rate trend confirmed this, the MetalSCAN counts were reset to zero and normal engine operation continued. The MetalSCAN detections resulted in an inspection of the D sump finger screen where some particles were found. ChipCHECK/debris analysis quickly confirmed the debris was cage plating and not M50 bearing steel. Normal engine operation continued.
