CASE STUDY

GE LM2500 POWER TURBINE BEARING FAILURE

Chip detectors and vibration sensors failed to detect an expanding bearing failure resulting in severe turbine damage and loss of service.

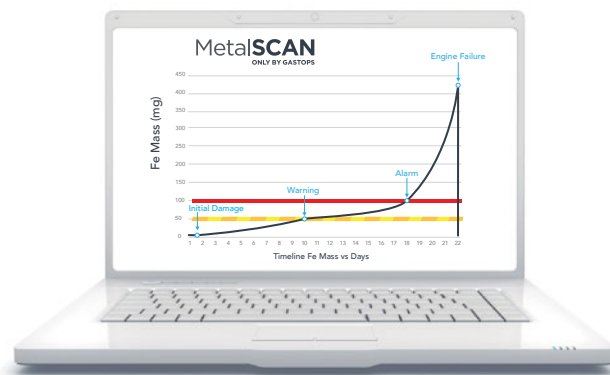
MetalSCAN counts rapidly increased above the MetalSCAN alarm limit, leading to a predicted bearing failure. This failure led to severe damage causing an engine trip that shut down the entire chemical plant production.

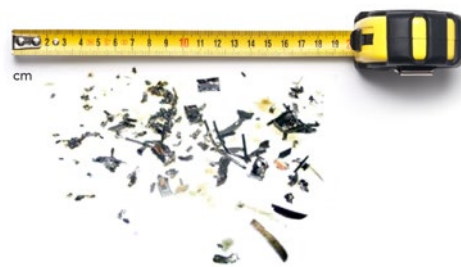
Metal Debris from B-Sump Screen
