# CASE STUDY

## GE LM2500 – Seal Failure

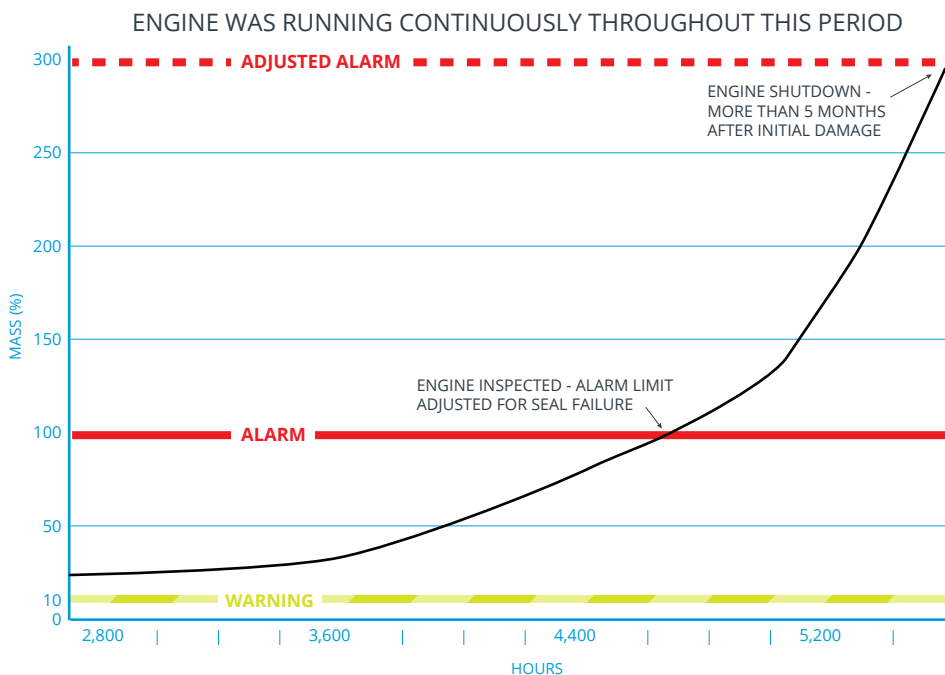
### Time History of Events

MetalSCAN began to detect particle counts on the C-Sump sensor and crossed the Warning Limit. The Alarm Limit was crossed 73 days later and the count rate continued to increase at a slow rate, atypical of a bearing failure. The customer adjusted the alarm limits for an oil seal failure, and the engine continued to run for an additional 35 days before shutdown. The engine was inspected and the rotational and stationary oil seals on No. 5 bearing were found to be failing, there was no damage to the bearings.

- ✓ Only the last 120 days shown
- ✓ Slow accumulation indicated a different failure mode (not the typical bearing failure)
- ✓ Engine inspection showed damage to oil seals
- ✓ MetalSCAN alarm limit adjusted given the different failure mode
- ✓ Unscheduled outage avoided
- ✓ Secondary damage avoided

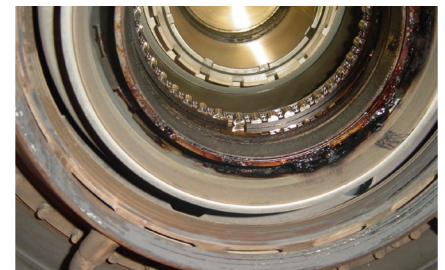
Damaged Oil Seal Face
