CASE STUDY

GE LM5000 – Power Turbine Bearing Failure

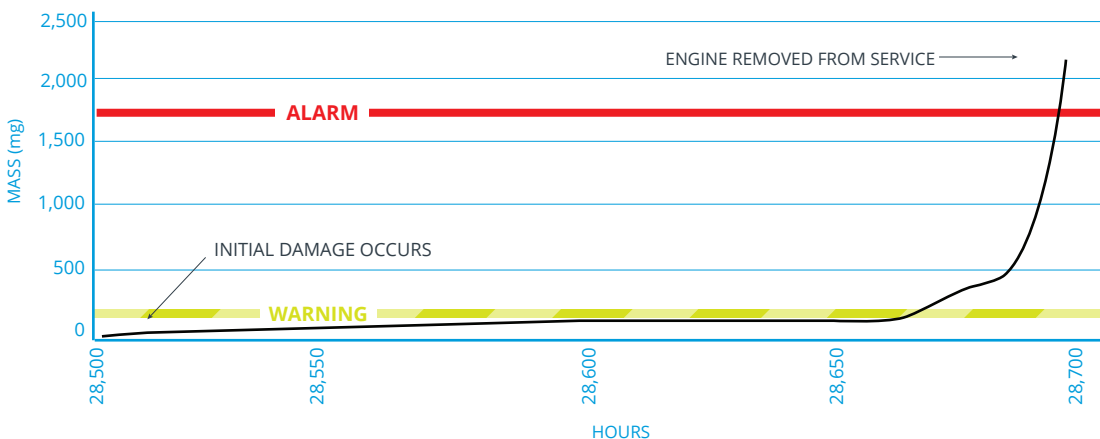
Time History of Events

The presence of particles indicated by MetalSCAN triggered an inspection of the PT scavenge pump magnet. A trace amount of debris was found attached to the magnet which led to the decision to keep the engine running, while closely monitoring the MetalSCAN trend. After six days, the warning limit was reached as the debris generation rate rapidly increased. After an additional 24 hours, the alarm limit was exceeded and the engine was stopped (seven days after initial debris detection).

ENGINE WAS RUNNING CONTINUOUSLY THROUGHOUT THIS PERIOD

- ✓ Only last seven days shown
- ✓ Engine ran for ~28,200 hours with virtually no debris detected
- ✓ 30 hour planning period provided
- ✓ Damaged located to power turbine
- ✓ Metallic debris was confirmed to be from power turbine bearing by inspection
- ✓ Secondary damage avoided
