CASE STUDY

GE LM6000 - 1B Bearing Failure

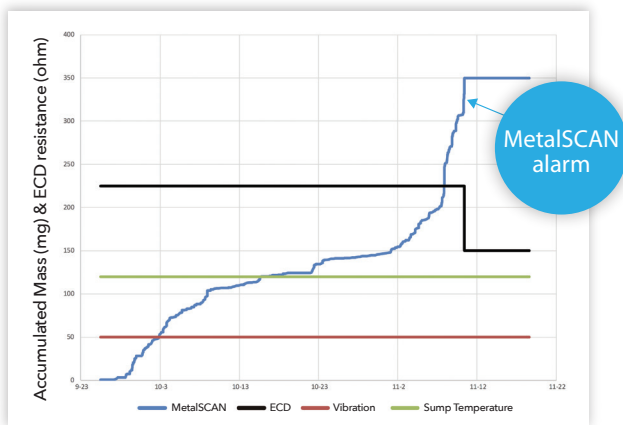
Time History of Events

In early November analysis of a filter (without shutdown) pointed to 1B bearing material. A lease engine was ordered while running continued. In early November the particle count rate began to increase and the alarm limit was reached by mid November, 44 days after the initial detection.

ENGINE WAS RUNNING CONTINUOUSLY THROUGHOUT THIS PERIOD

Only last 6 weeks shown
