CASE STUDY

GE LM5000 POWER TURBINE BEARING FAILURE

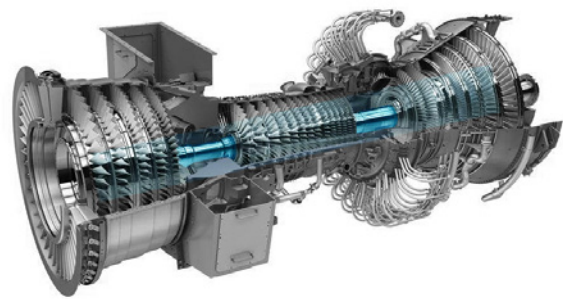
There was no other indication of a problem from vibration, temperature or the chip detector in the seven days of early warning from the MetalSCAN sensor.
