CASE STUDY

GE LM6000 1B BEARING FAILURE

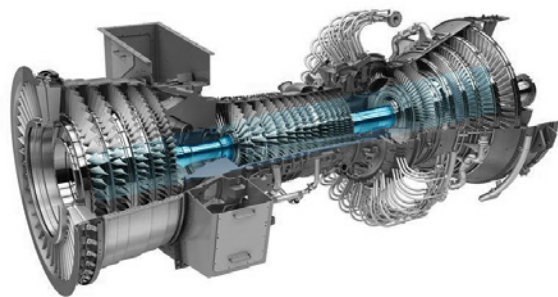
There was no other indication of a problem from vibration, temperature or the chip detector in the 44 days of early warning from the MetalSCAN.

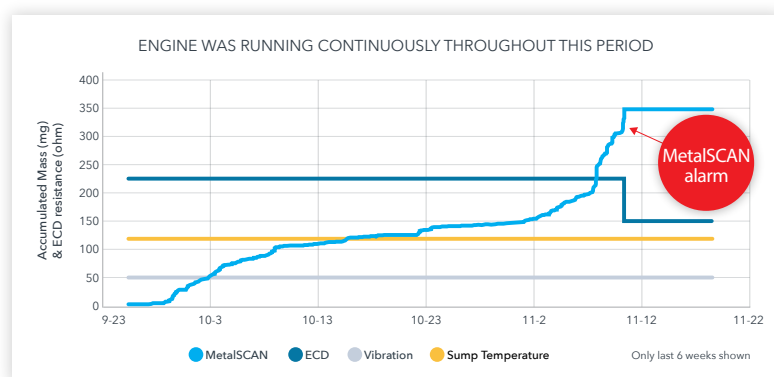
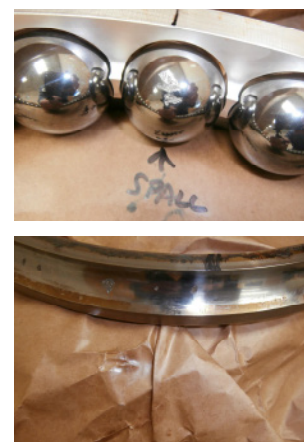
The operator was able to schedule the engine replacement to coincide with the arrival of the lease engine. Engine teardown at the depot confirmed that the 1B Bearing damage correlated very well with the MetalSCAN damage alarm indicator.
