**CASE STUDY**

**P&W FT8 – Power Turbine Bearing Failure**

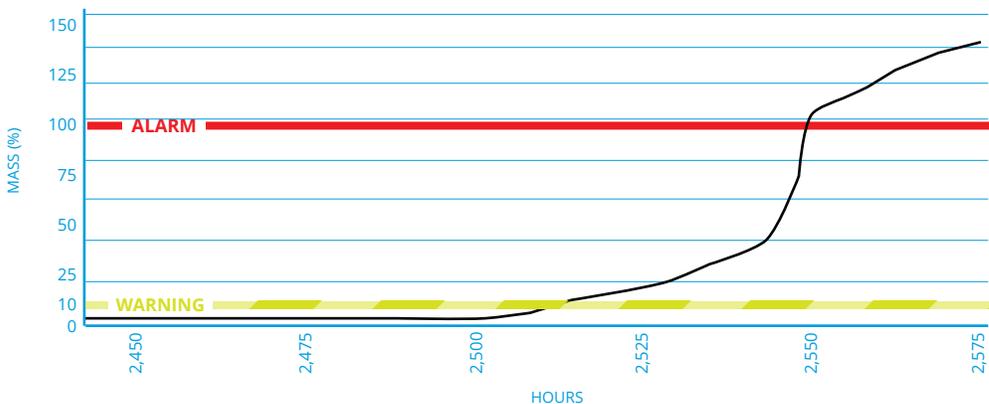
**Time History of Events**

Presence of particles first detected by MetalSCAN at 2,500 operating hours, followed by a sharp rise at 2,525. Replacement power turbine dispatched from spares pool. A chip detector alarm was triggered at 2,550 hours. At 2,575 hours, the turbine was shut down based on readings from MetalSCAN and the power turbine was changed out. At shutdown, the total debris mass on #8 and #9 scavenge line was over the MetalSCAN alarm limit with no change in vibration or scavenge oil temperature. The MetalSCAN sensors monitoring the other bearings showed no rise of debris.

ENGINE WAS RUNNING CONTINUOUSLY THROUGHOUT THIS PERIOD
