**CASE STUDY**

**P&W FT8 – Power Turbine Bearing Failure**

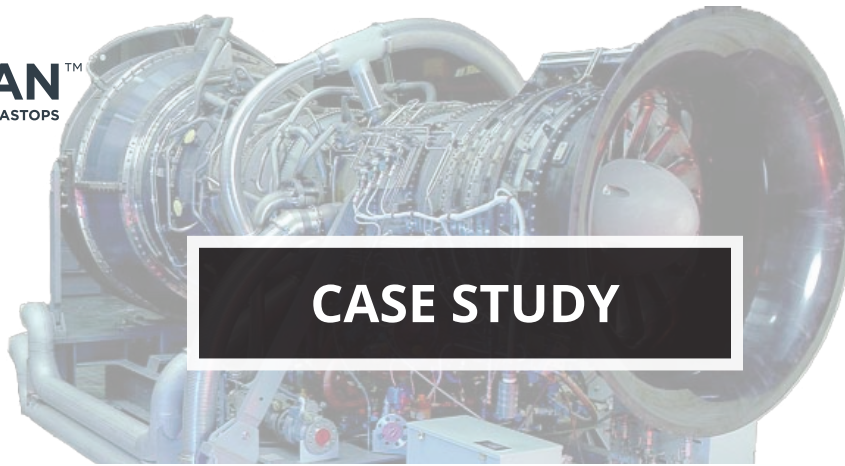
Damaged Bearing

An FT8 had run for 1,700 hours with no debris detection. Debris began to be detected on the power turbine MetalSCAN sensor. Peak demand for power is on weekdays, the unit is curtailed on weekends.

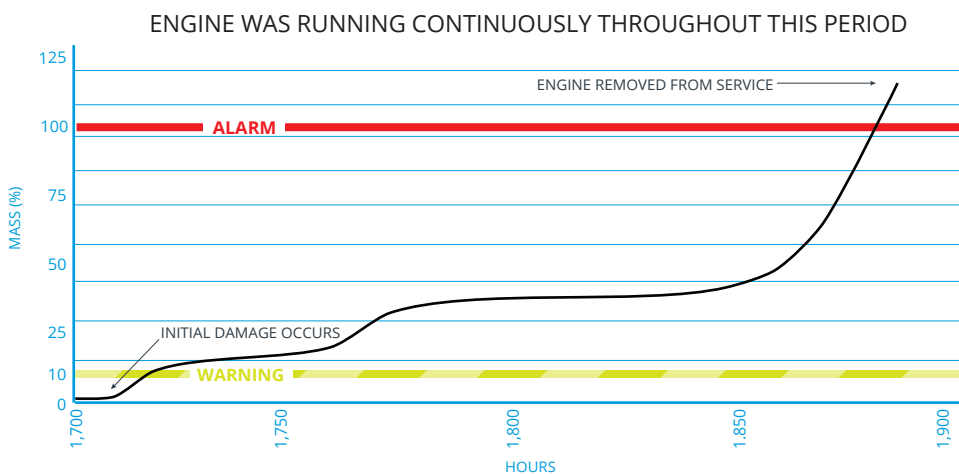
**Time History of Events**

MetalSCAN first began to detect particles on the PT sensor on a Tuesday and climbed steadily through the warning level by early Wednesday. With close monitoring of the MetalSCAN data the engine continued to be run at full load until the weekend, with the particle counts continuing to rise. With reduced power demand on the weekend the engine operation was curtailed to 70% load which resulted in a flattening of the particle count trend. As the load was increased again after the weekend, the particle count trend increased at a steeper rate and the alarm level was surpassed before the middle of the week. The operator was able to easily and effectively monitor the bearing damage severity with MetalSCAN, with no chip detector or vibration abnormalities indicated, and keep the engine running through the peak revenue generating periods. The engine teardown confirmed that the damage was contained to the bearing inner race (spallation) and correlated well with the MetalSCAN alarm limit. Secondary damage was avoided and down time was minimized.

- ✓ Only last eight days shown
- ✓ Engine ran for ~1,700 hours with virtually no debris detected
- ✓ 175 hour planning period provided
- ✓ Curtailed operation to 70% load through weekend
- ✓ Secondary damage avoided
- ✓ Damage isolated to the power turbine
