CASE STORY

Senvion MM92 2MW Wind Turbine (08008)

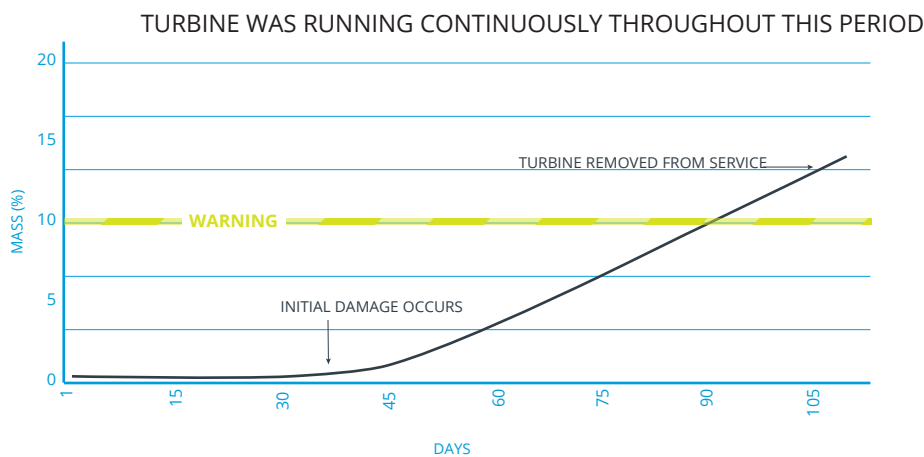
Time History of Events

One month after installation, MetalSCAN detected debris increases and the cumulative counts crossed the warning limit (10% of the alarm limit) triggering a videoscope inspection. The high rate of accumulation suggested the possibility of high-speed bearing damage. The videoscope inspection confirmed damage to the inner race of the high-speed bearing. As a result, the wind turbine was stopped and the high-speed bearing was replaced uptower. The wind turbine was restarted and the MetalSCAN trend indicated a healthy gearbox.

Damaged High - Speed Bearing

ONLY TIME SINCE METALSCAN INSTALLATION SHOWN
