CASE STUDY

GE LM5000 POWER TURBINE BEARING FAILURE

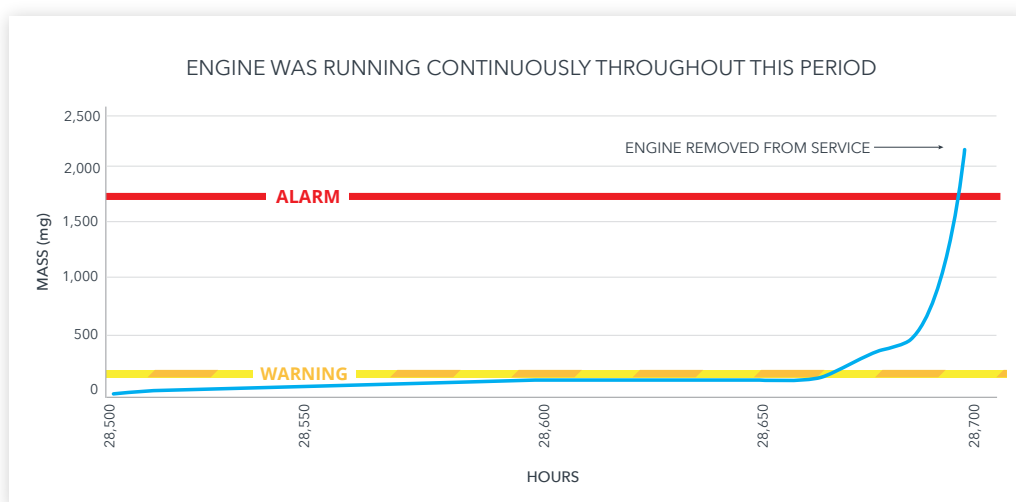
The engine had been operating continuously for 28,200 hours with normal healthy indication of bearing condition when the MetalSCAN sensor on D-Sump detected the presence of ferrous debris indicating damage initiation on the power turbine. A trace amount of debris was found attached to the magnet which led to the decision to keep the engine running, while closely monitoring the MetalSCAN trend, and begin planning for an upcoming maintenance activity.

As the engine continued running, there was a steep rise in counts which triggered the warning after six days.

Seven days after the initial debris detection the alarm limit was reached at which time the engine was shut down.

The teardown inspection revealed damage limited to power turbine bearings and no secondary damage. The bearing repairs were completed within the scheduled maintenance period.

The engine was running continuously up to the day of the maintenance period. The power turbine was replaced with minimal engine down time.
