User Application

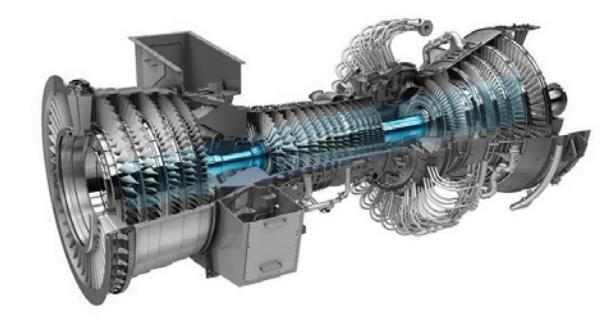
Apart from slightly higher readings on the C-Sump scavenge temperature, no other engine parameters (including chip detector or vibration readings) indicated abnormalities.

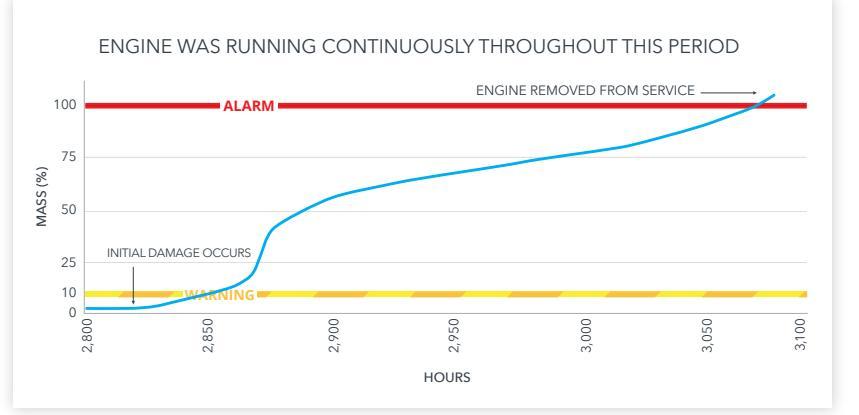
The engine had been operating continuously for three months since MetalSCAN was installed on this unit. An increase in debris accumulation was first detected by the C-Sump MetalSCAN sensor.

As the engine continued running, within one day there was a steep rise in counts which triggered the alarm. The engine power was subsequently reduced to 80% of the normal base load to slow damage progression and allow operation until a scheduled maintenance period.

The alarm limit was reached nine days later, at which time the engine was shut down the day before the scheduled maintenance period.

The teardown inspection revealed damage limited to #5 and #6-Bearings, and no secondary damage. The bearing repairs were completed within the scheduled maintenance period.
